**(j) OAK TREE PRESERVATION INCLUDING SYCAMORE AREA
INVENTORY BASELINE MATERIAL IN EIR/CONCERN WITH
CONCRETE LINED DITCHES IMPACTING RIPARIAN VEGETATION.**

Oak Tree Report

Estrella River Vineyard

Tract 2905

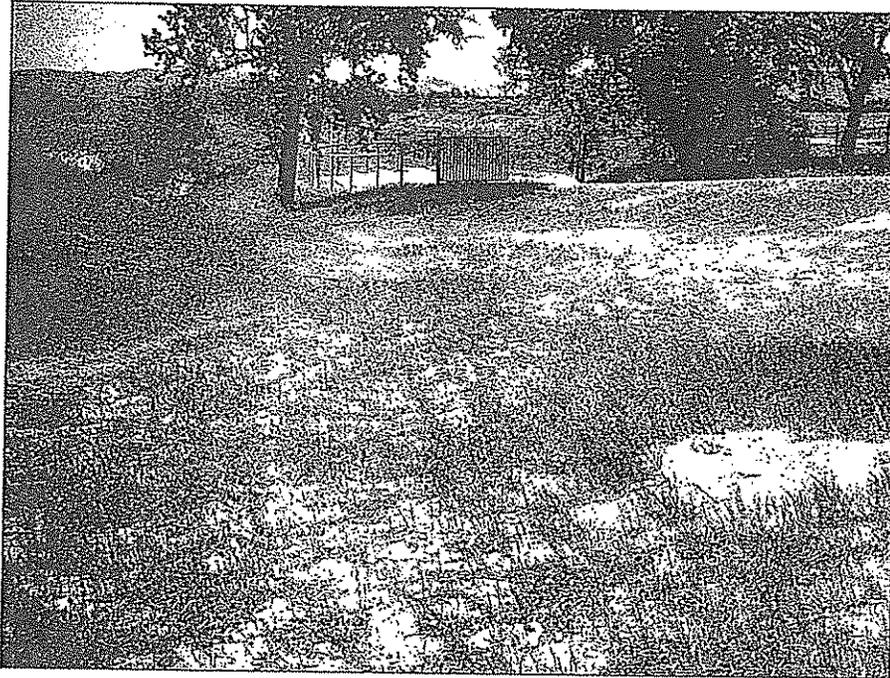
Photo 1. View north of the front gate entrance to the property from Estrella Road. The existing vineyard road would be re-aligned. Tree #1, pictured left of the gate, would be impacted.

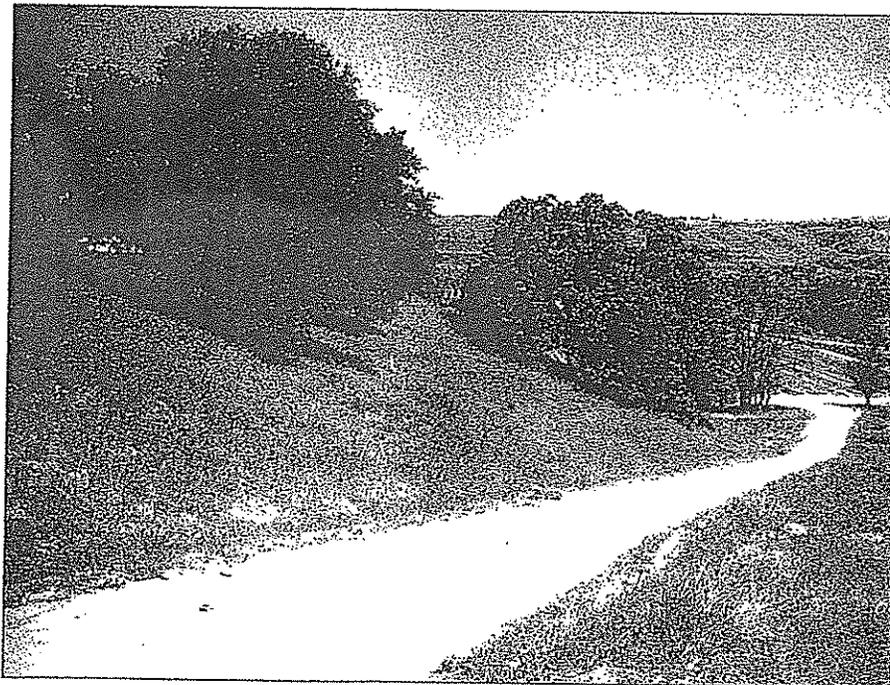
Photo 2. View north of the existing agricultural road along the east property border that would be paved and widened. The deciduous trees at the base of the road are non-native tree of heaven. Native blue oaks are visible at left.

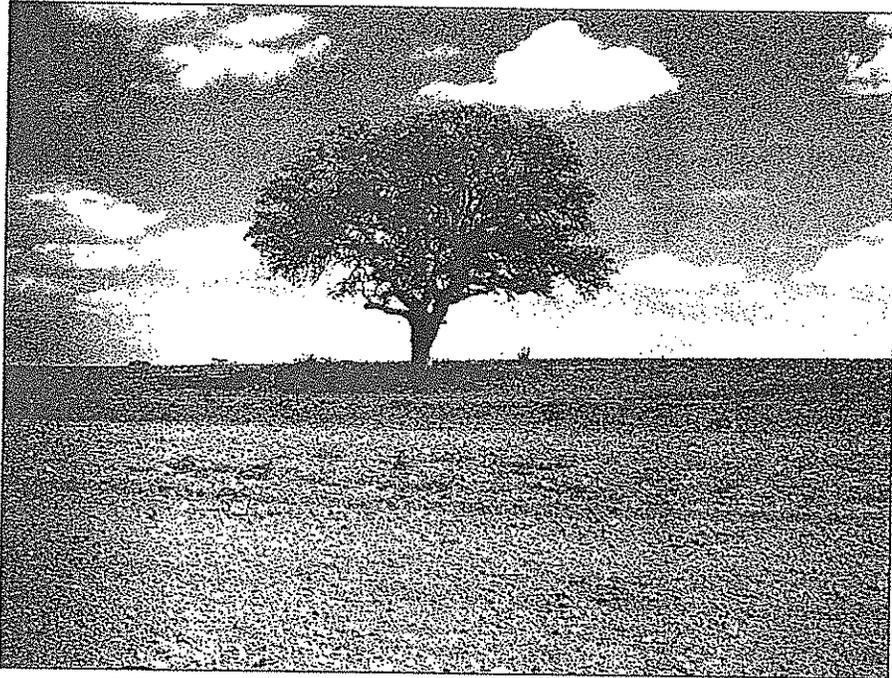
Photo 3. Tree #15 is a 33 inch blue oak (rated "C") located in an existing agricultural field, where the ground is plowed seasonally within the CRZ. The proposed access road would require paving within the CRZ.

- a. It appears from the site plan that paving would occur within the CRZ of several oak trees. Any paving within the CRZ shall be done with porous pavers that will allow oxygen and moisture exchange to occur within the root zone.

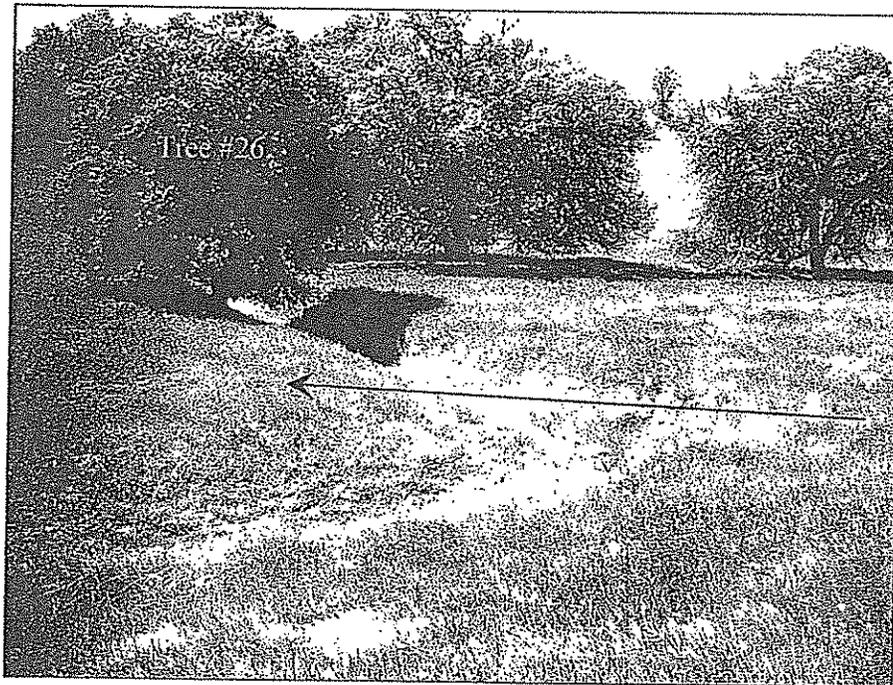
Photo 4. Tree #26 is a very healthy blue oak (rated "A") located along an ephemeral drainage. The southern drainage crossing is proposed at this bend in the stream (note arrow), and would encroach within the CRZ of this tree.

Many of the anticipated oak tree impacts could be avoided by modifications of the road alignments.

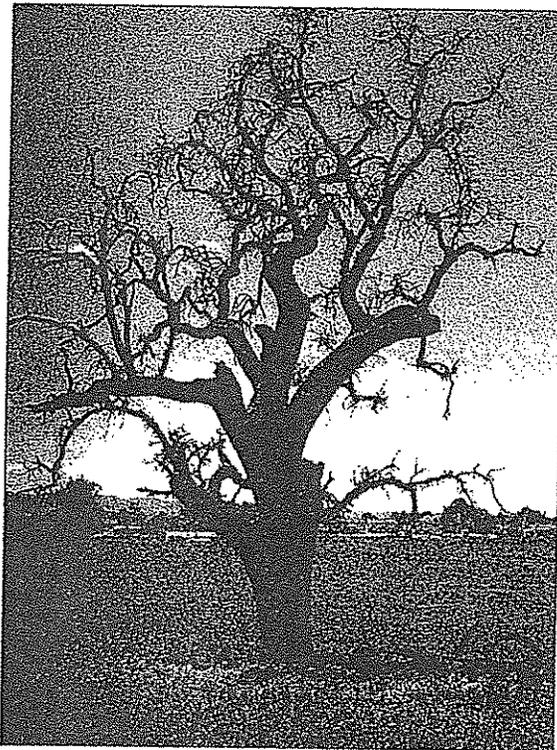
Photo 6. Tree #97 is a valley oak in poor health. It has numerous natural cavities, including one harboring a barn owl nest. Although it is nearly dead, it was rated "D+" because of its habitat value to wildlife.

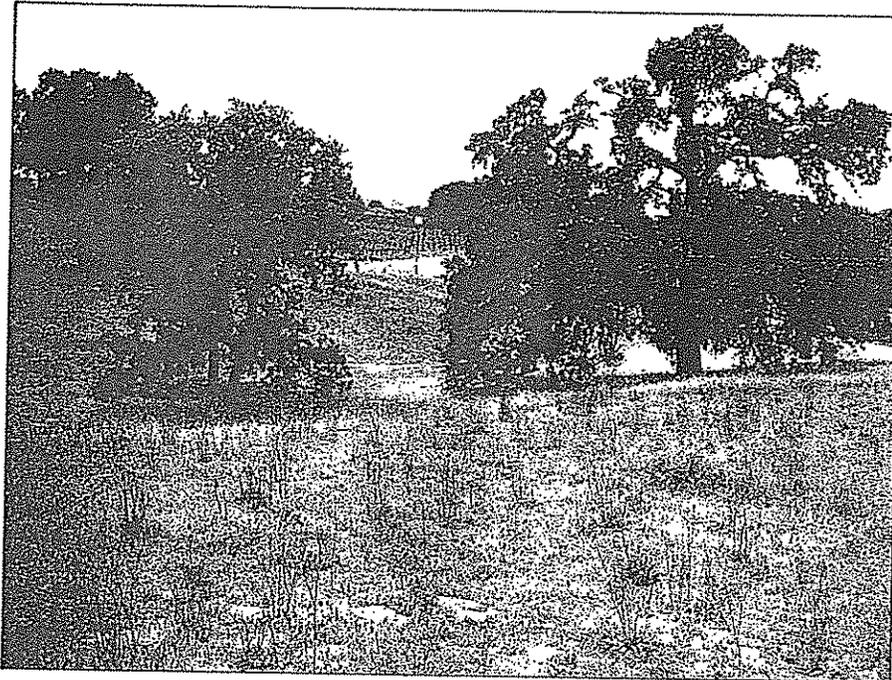
Photo 7. View northwest of Tree 8 (right) and Trees 101 and 102 (left) near the front entrance gate at Estrella Road. The proposed entrance road would pass between these trees, resulting in CRZ encroachment impacts.
