# HISTORIC OAK GROVE BRIDGE

## ENVIRONMENTAL SCOPING MEETING

February 23, 2016

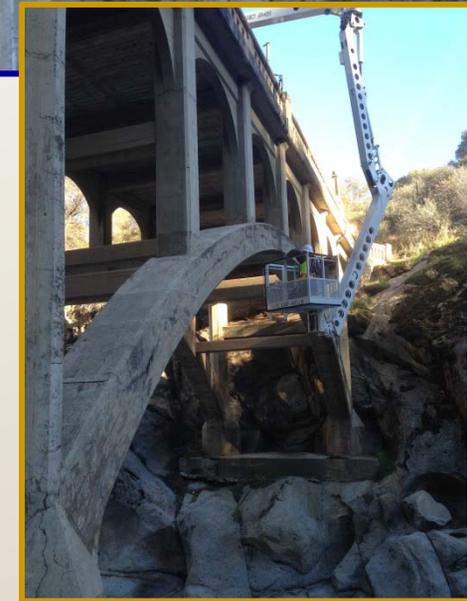
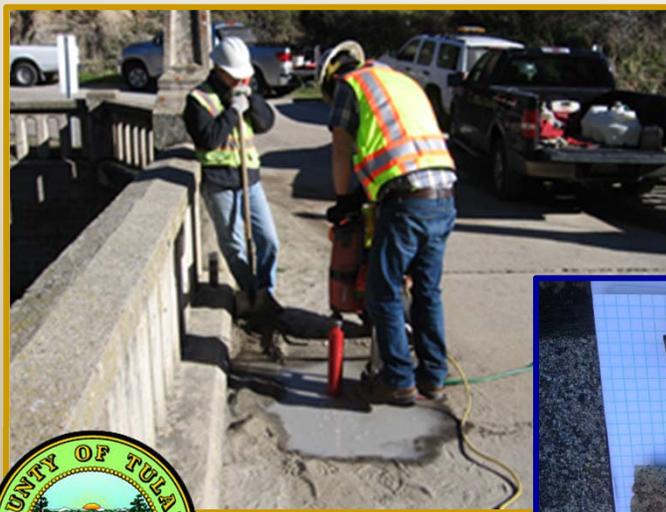
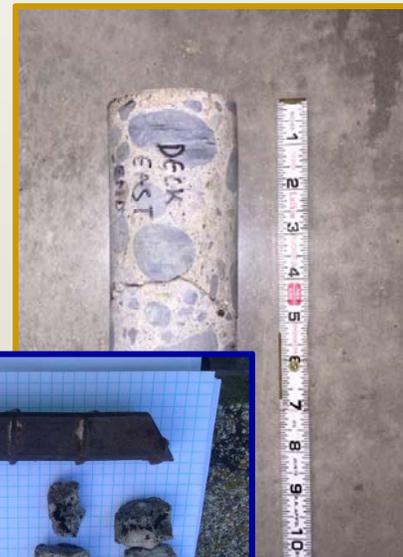
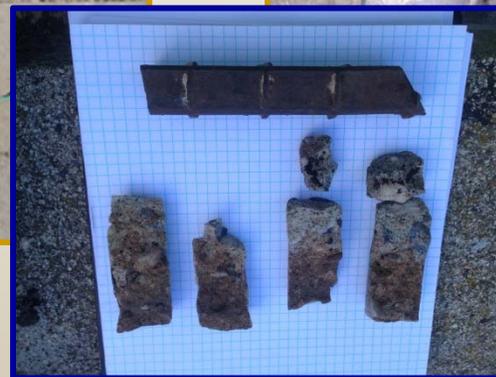
# BRIDGE INVESTIGATION

## Detailed Field Investigation

- Completed January 6, 2015
- Caltrans, Cornerstone, & County Staff
- Visual Inspection & Concrete Sounding
  - Caltrans UBIT Truck – Additional Access
- Material Samples
  - 5 Concrete Cores
  - 1 Rebar Sample

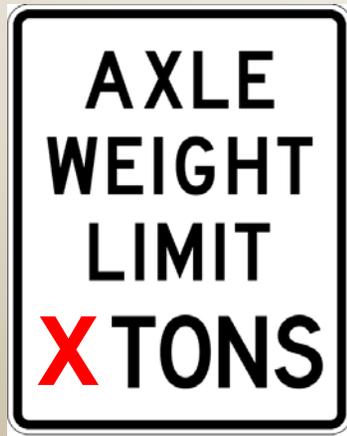
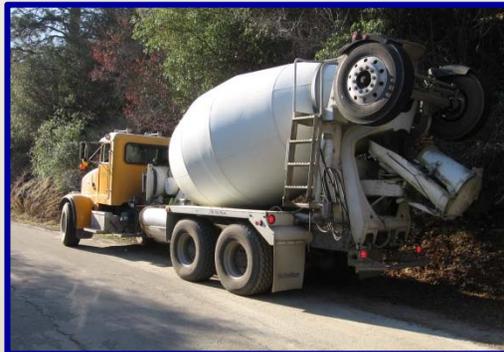
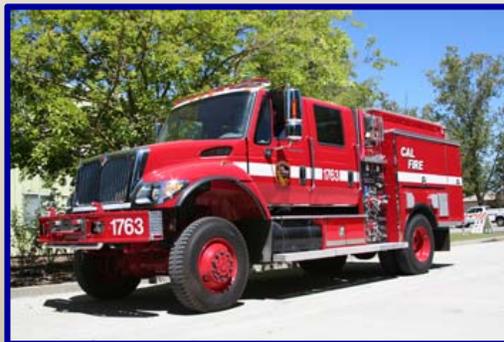
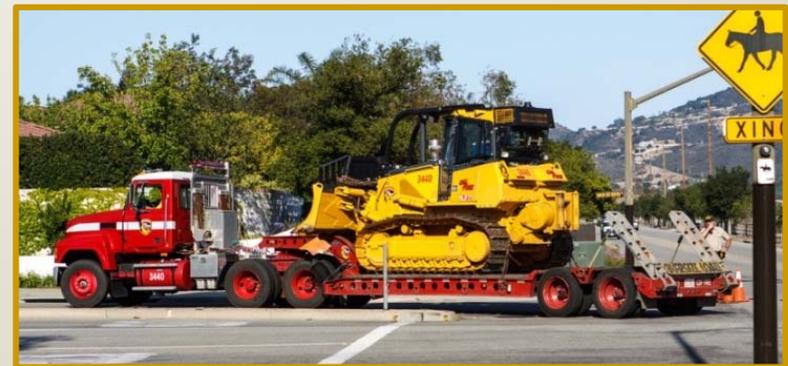
# BRIDGE DEFICIENCIES

## Inadequate Load Capacity

- Deficient Deck & Deck Support Beams
- Bridge Requires Load Posting
  - Posting being Coordinated with Caltrans
  - Public Hearing
- Correction will Require Significant Impacts

NATIONAL BRIDGE RATING LOADS		
Bridge Element	Federal Standard	Oak Grove Bridge
Deck	36 Tons	14 Tons
Support Beams	36 Tons	30 Tons

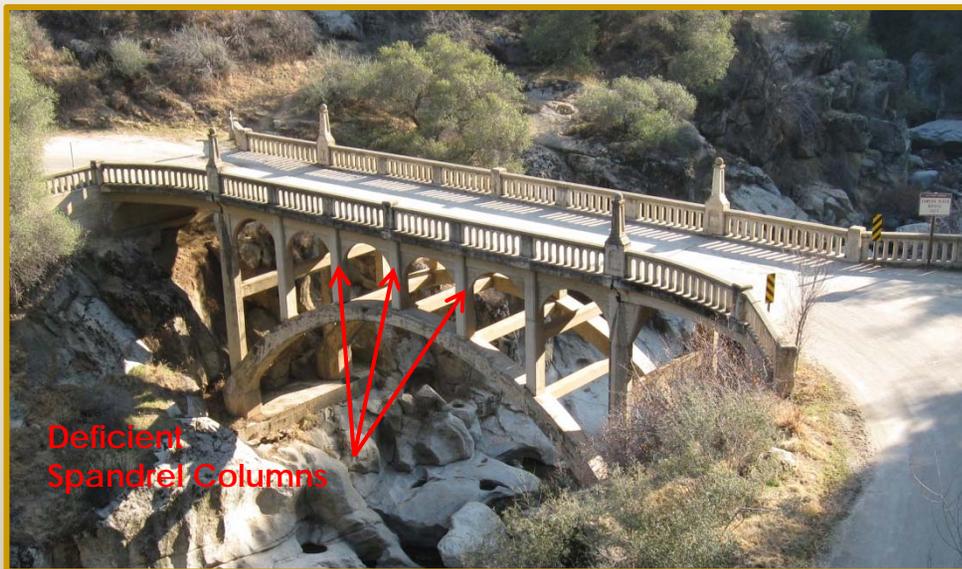
# BRIDGE DEFICIENCIES

## Seismically Vulnerable

- Deficient Spandrel Columns
- Likely Collapse During Design Earthquake

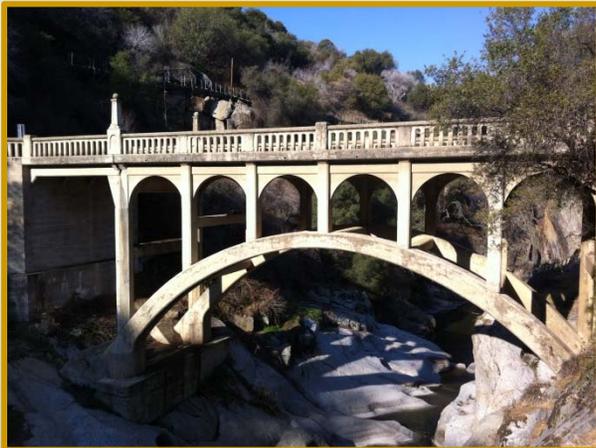
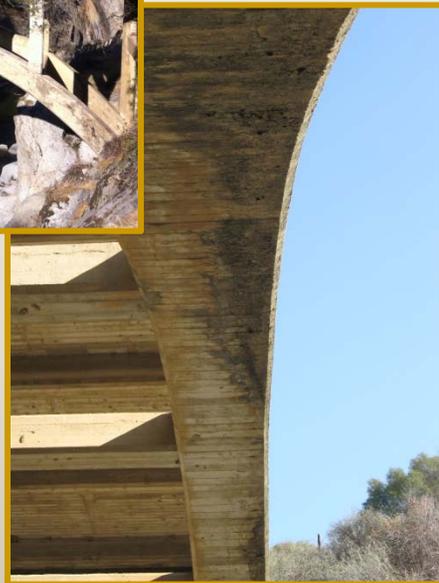
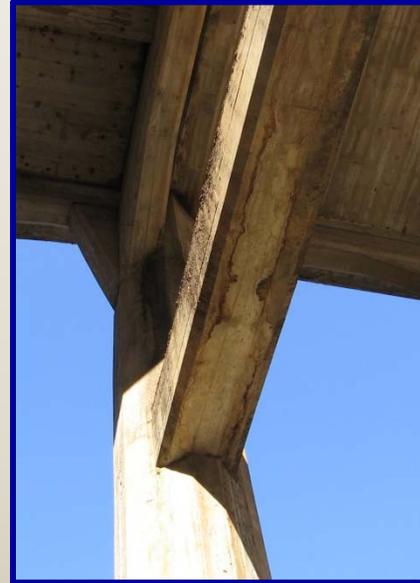
# BRIDGE DEFICIENCIES

## Joint and Drain Failure

- Open Joint
- Water Drains onto Bridge

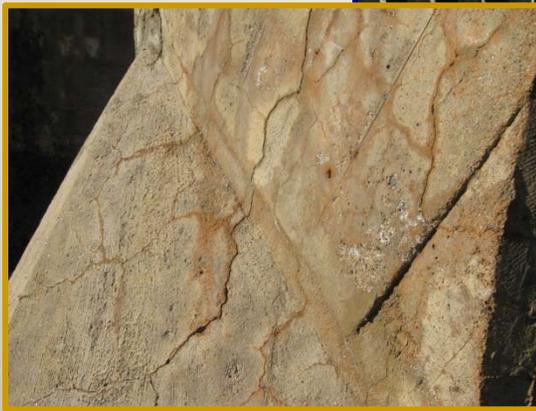
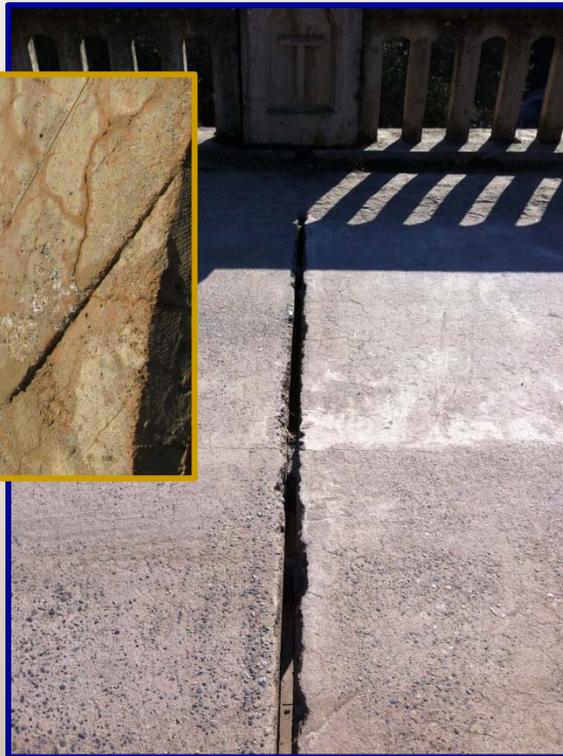
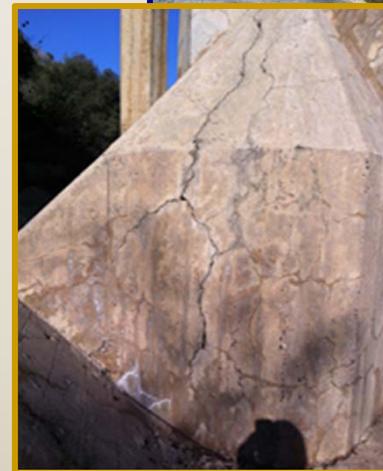
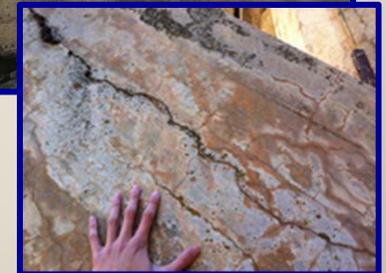
# BRIDGE DEFICIENCIES

## Concrete Deterioration

- Cracks Throughout Bridge
  - Concentrated Where Water Collects and in Shadowed Areas
  - Large Cracks (>1/4") in Arches
- Deck Cracks in Main Span
- Delamination Starting

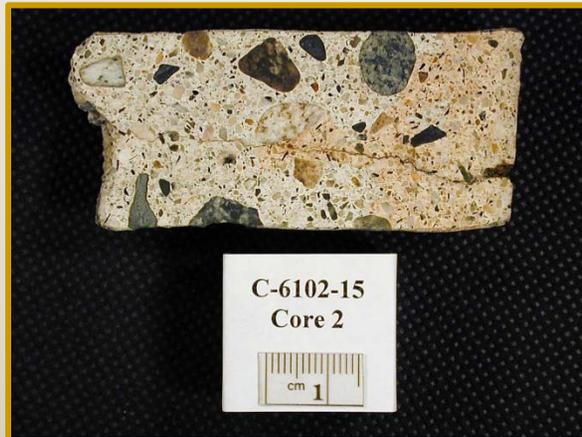
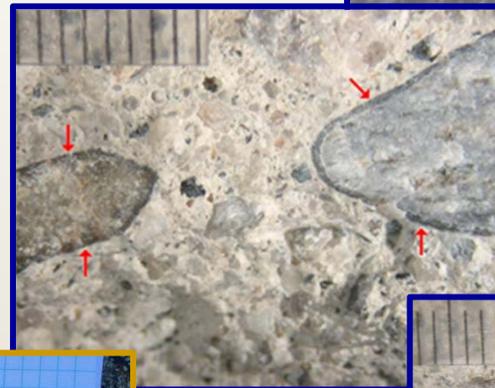
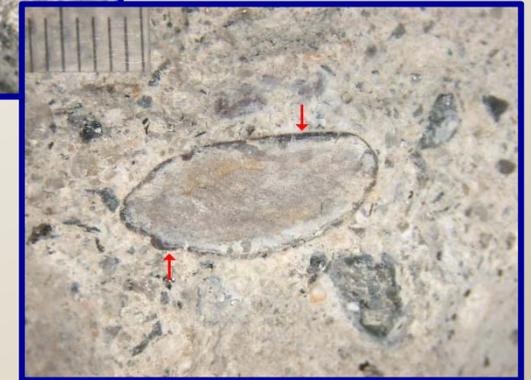
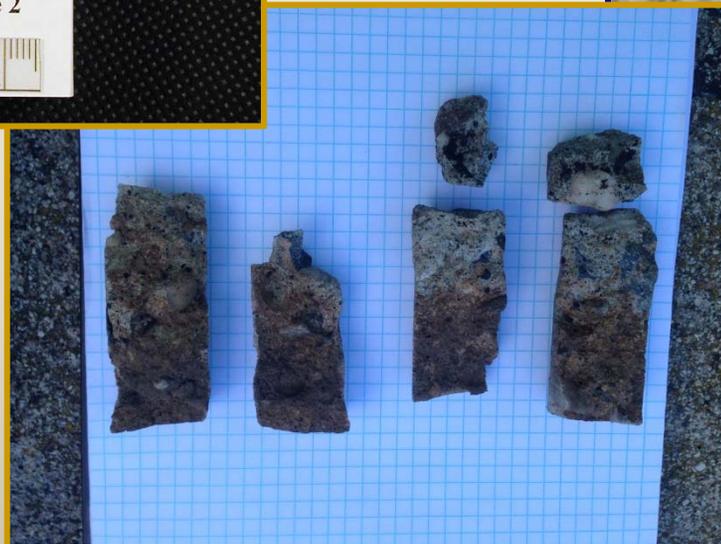
# BRIDGE DEFICIENCIES

## Concrete Deterioration

- Causes of Deterioration
  - Age
  - Alkali-Silica Reaction (ASR)
  - Carbonation

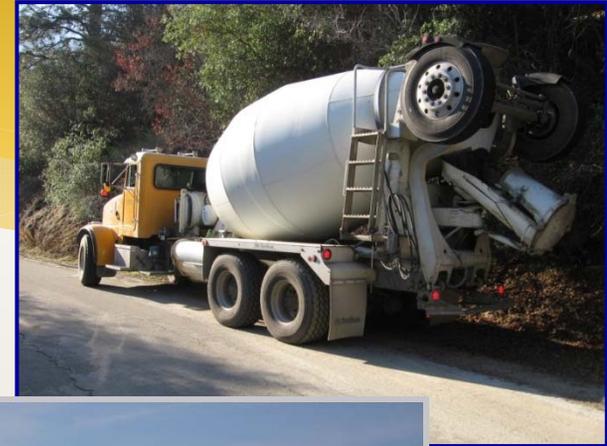
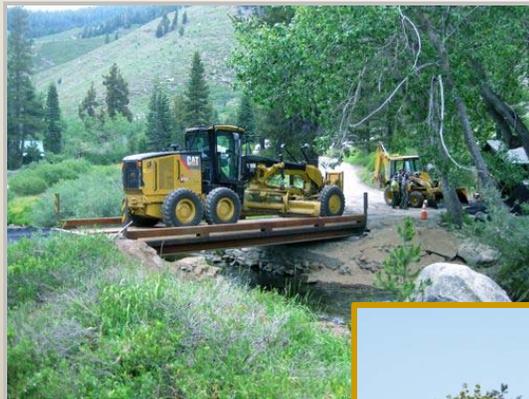
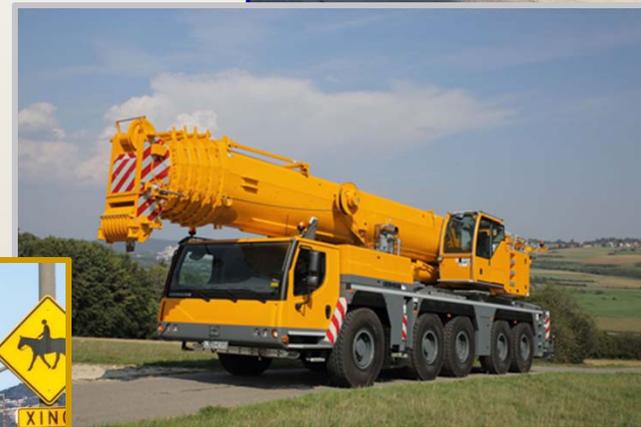
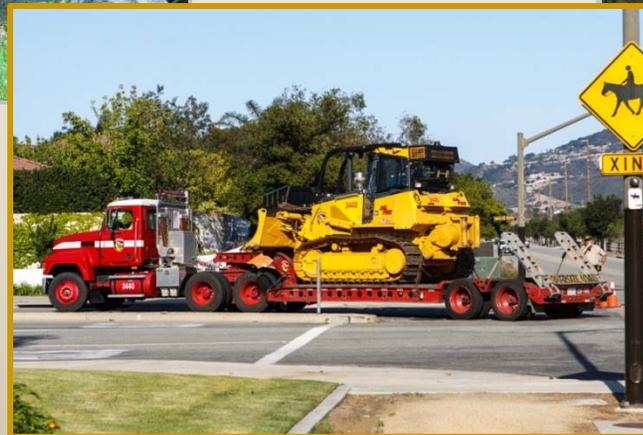
## Site Access

- Route Survey Completed by Reeve Trucking
- 28 ft. Long flat-bed Trailers
- 265-ton All-Terrain Crane
- Concrete from CEMEX plant in Farmersville, CA
- Cal Fire Dozer Transport
